## Determination of radon transmittance

RISE was requested to measure the radon transmittance through one membrane in accordance with SP Method no. 3873.

The client delivered one sample of their product which was named Haloproof RMS 300 to RISE Research Institute of Sweden on 2025-02-20. There were no signs of visible damage to the material on arrival. The material thickness was measured by RISE according to SS-EN 1849-2:2019, see report O100282-1308324-1. The material was tested without joints. See Appendix 2 for a picture of the material.

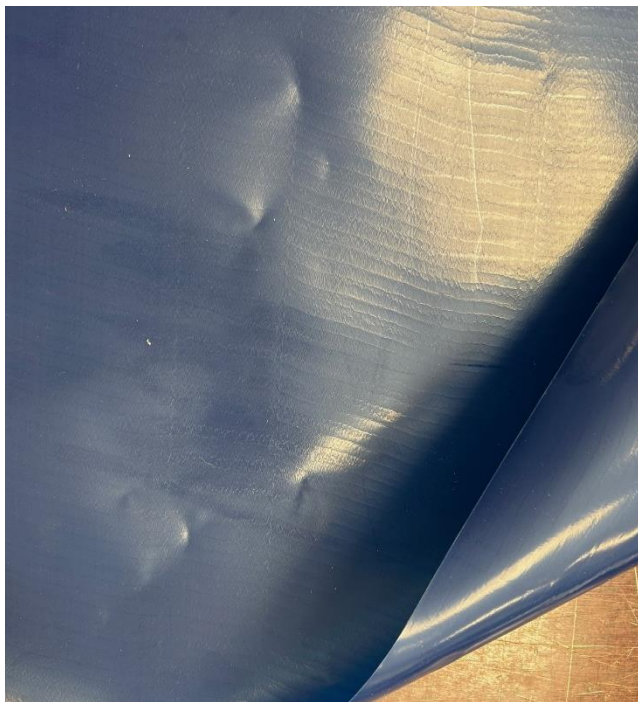
Haloproof RMS 300

**Photograph of the tested material**
